NEW REPAIR METHOD FOR A 380KV-FLUIDFILLED CABLE, DAMAGED BY IMPACT

Georg **SVEJDA**, Wien Energie Stromnetz, (Austria), georg.svejda@wienenergie-stromnetz.at,
 Johannes **VAVRA**, Wien Energie Stromnetz, (Austria), johannes.vavra@wienenergie-stromnetz.at
 Manfred **WANDA**, PRYSMIAN, (Austria), manfred.wanda@prysmian.com
 Nick **CRANE**, PRYSMIAN, (England), nick.crane@prysmian.com

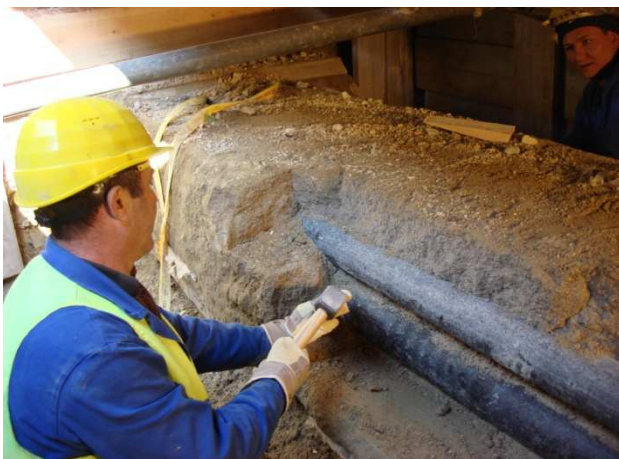
Fig.1 Removing backfill material with wooden wedges

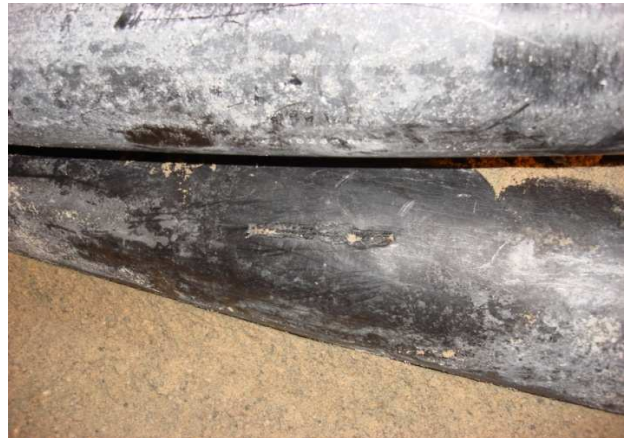
Fig. 2 Damage on a 380kV-Fluidfill cable

During work to connect the originally installed water cooling pipes (these were originally only nitrogen filled to allow leak detection if damaged by 3rd parties) to a new cooling station to allow the cable circuit to be water cooled and updated. It was necessary to expose the cooling pipes by carefully removing the backfill material by using wooden wedges (1). The situation near the old reversal point of the cooling pipes was different to the as built drawing. The backfill material was different in hardness to that which would normally have been installed thirty years ago. It was therefore difficult to distinguish the contact between the wooden wedge backfill or cable.

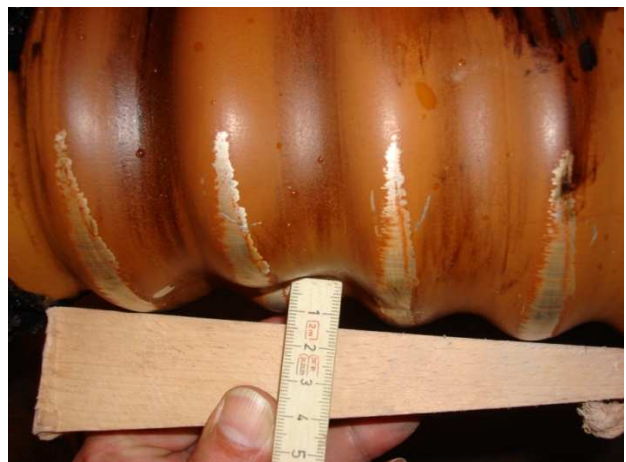
Fig. 3 Corrugated Aluminium Sheath damage after removal of outer polythene sheath
