MV CABLE TERMINATION FAILURE PREVENTION, ONLINE DIAGNOSTIC METHOD APPLICATION.

Thierry **ESPILIT** (1), Fabrice **ZORZI** (1), Roger **TAMBRUN** (2),

1 - EDF R&D, Moret sur Loing, France, thierry.espilit@edf.fr, fabrice.zorzi@edf.fr

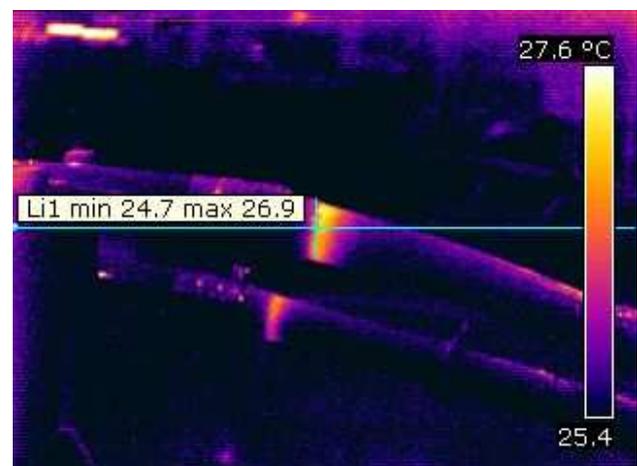
Figure 1 : Stress control heating under nominal voltage

Moreover, temperature increase of the stress control material has been observed under nominal voltage application.

A combination of initial bad adhesion and thermal degradation of the stress control material due to load and
