EXPERIENCE WITH JOINT FAILURES IN NEW SMART-GRID MV CABLE CIRCUITS

Frank **DE VRIES**, Liandon BV, (The Netherlands), frank.de.vries@alliander.com
 Jacco **SMIT** Liandon BV, (The Netherlands), jacco.smit@alliander.com
 Ger **SEBREGTS**, Liander NV, (The Netherlands), ger.sebregts@alliander.com

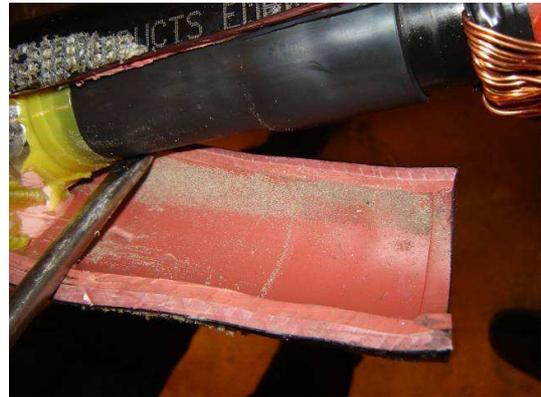
Fig. 1 Example of insufficient installation of a MV joint

This approach has proven to be successful. In figure 1 an example of poor workmanship can be seen because of the presence of sand within the joint body which has been found by PD measurement. Besides after laying tests, Liander is also involved in the training of contractors and employees to improve installation work and to minimize failures caused by poor workmanship.
