## Electrical and physical characterisation of a 138 kV XLPE insulated cable with 12 years service life

*In the present study a length of a 138 kV crosslinked polyethylene (XLPE) insulated cable that has been in service for 12 years has been characterised with electrical, visual and physical testing. A description of the service conditions will be given. The electrical characterisation includes electrical tests such as PD testing, AC voltage withstand test, dissipation factor and lightning impulse testing. The physical characterisation includes measurements of the degree of crosslinking, tensile properties, degree of crystallinity and thermo-oxidative ageing studies. The obtained results are discussed and compared with requirements in the ICEA S-108-720-2012 standard.*

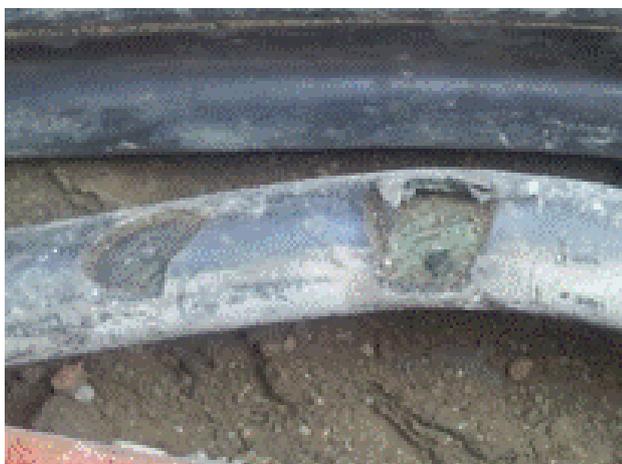
In 1996 Commonwealth Edison (ComEd) an Exelon company based in Chicago, Illinois, U.S.A. began an unprecedented cable replacement program. The goal for phase I was to replace 33 circuit miles of 138 kV Low Pressure Fluid Filled (LPFF) cables with crosslinked polyethylene (XLPE). At that time XLPE cable technology was new not only to ComEd but also to the U.S. The concern has always been what the life expectancy of XLPE cables would be when compared to the long life that fluid filled systems have provided for decades. Due to a third-party dig-in as shown in Fig. 1, ComEd had the chance to remove and test the section of damaged cable that had been operating successfully for the prior 12 years.

Fig. 1: Damaged 138 kV XLPE cable.
