Significant partial discharge in silicone insulated HV joints during livening

Duncan O'DONNELL, Do Consulting, (New Zealand) , duncan@doconsulting.co.nz,

Partial discharge testing was carried out to investigate the root cause of two failed 220kV silicon insulated cable joints. Remarkably PD bursts up to 8nC were discovered during network switching. This activity was intermittent lasting less than 20ms, therefore unable to be detected during routine insulation testing.

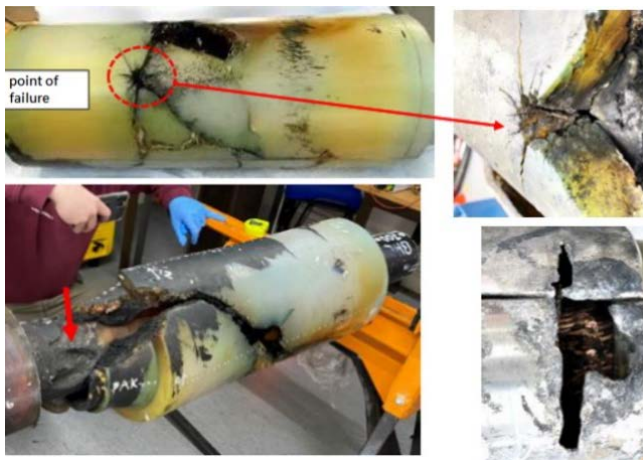
Fig. 1. 2020 failed yellow phase joint.

(Arcing exit hole identified in top images, damaged corona shield identified in bottom images.)

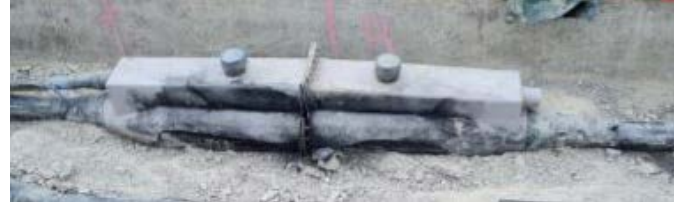
Fig. 2. 2021 failed blue phase joint. (Failed blue phase is the top joint in the photo.)

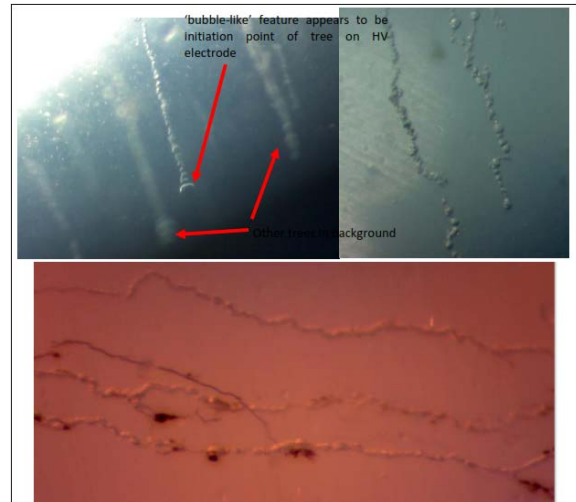
Alarming extensive electrical treeing was discovered in the silicon insulation of cable joints that had not failed yet. Therefore a PD phenomenon must be taking place deteriorating cable joint silicon insulation.

Fig. 3. Electrical treeing observed in joint insulation

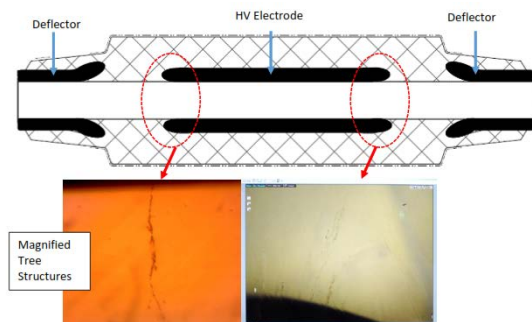
Fig. 4. Treeing in silicon joint insulating sleeves
