Accelerated Aluminum Corrosion upon Water Ingress in Damaged Low Voltage Underground Power Cables.

Bart **KRUIZINGA**, Peter **WOUTERS**;

Eindhoven University of Technology, Electrical Energy Systems group,

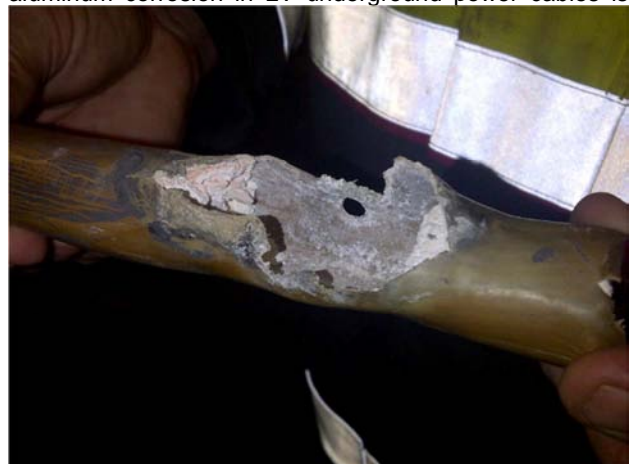
For economic reasons, aluminum conductors have become the most attractive alternative to previously more often used copper conductors. In many cases, LV cables are completely or partly submerged in water due to ground water levels. In such cases, corrosion could occur. In previous research, corrosion of LV cables in relation to a steel screen has been reported [1]. Grid operators have reported what appears to be a corrosion process on aluminum conductors in LV cables. A powder-like white substance is formed with large volumes. This substance is released locally from a damaged location, and extends much wider than the cable cross-section. In these cases, part of the aluminum conductor cross-section has disappeared over lengths up to several decimeters. An illustration is given in figure 1. The underlying process is so far not well understood.

Fig. 1: Example of a cable section affected by aluminum corrosion. Unattached aluminum hydroxide is removed to show the extent of aluminum removal by the process.
