Fault Location, Failure Analysis and Repair of 115kV SCFF Cable System Highlighting Important Asset Management Strategies

ABSTRACT

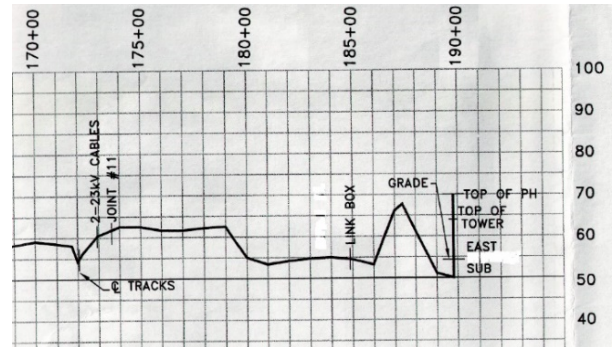
Fig. 2: SCFF Circuit Profile

The B phase cable had a cable fault occur at the top of a hill near the point of highest elevation along the circuit (see Fig. 2). This is also the point along the circuit under the lowest fluid pressure.

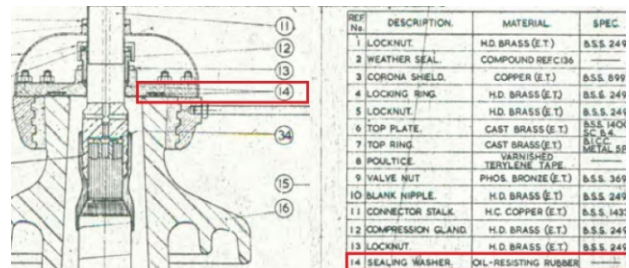
Fig. 3: Termination Top Assembly Seal

An initial visual inspection was conducted and a small leak on the B phase termination at the substation was discovered. The leak occurred at the top assembly of the termination. The termination was an older design and had a sealing washer made of oil-resistant rubber (see Fig. 3). Over time, the rubber had degraded and ultimately resulted in an oil leak. After locating the issue, the leak was contained and the contaminated gravel in the surrounding area was disposed of in accordance with environmental regulations.

While the leak may have contributed to the failure, this was not the ultimate cause of the fault since the pressure never dropped low enough to trigger the low-pressure alarms. At this point, it was not clear what caused the cable to fail.
