# A Study on the Effect of Performing VLF Withstand Tests on Field Aged Degraded Joints

Jean-François DRAPEAU

Jicable'11

21 June 2011

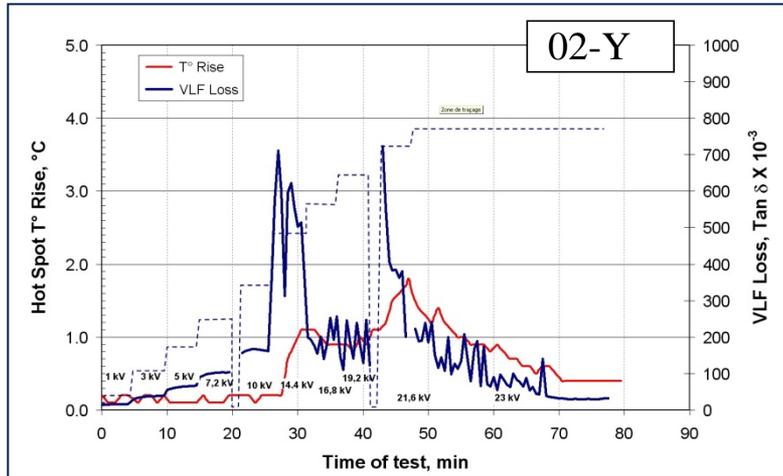
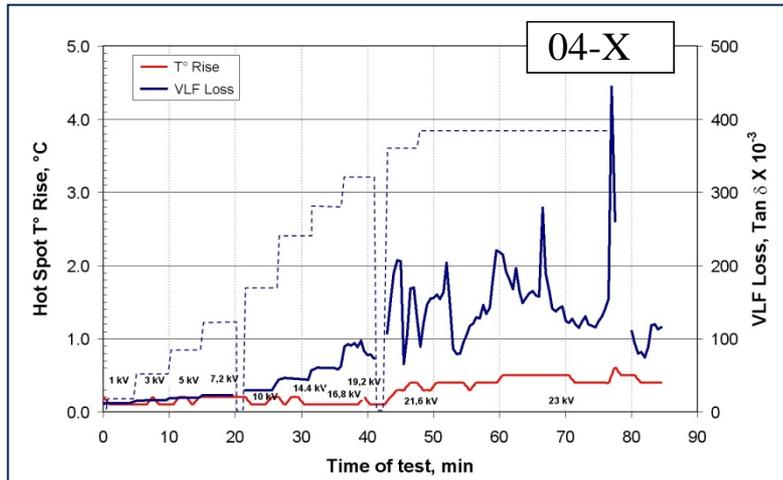
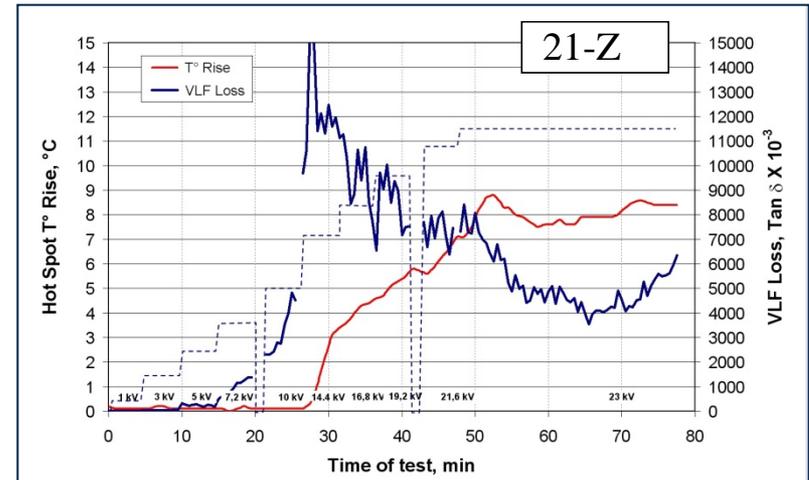
### UNEXPECTED LOSS BEHAVIOR DURING VLF MONITORED WITHSTAND

Dielectric loss show several huge quasi-instantaneous variations (increase or decrease)

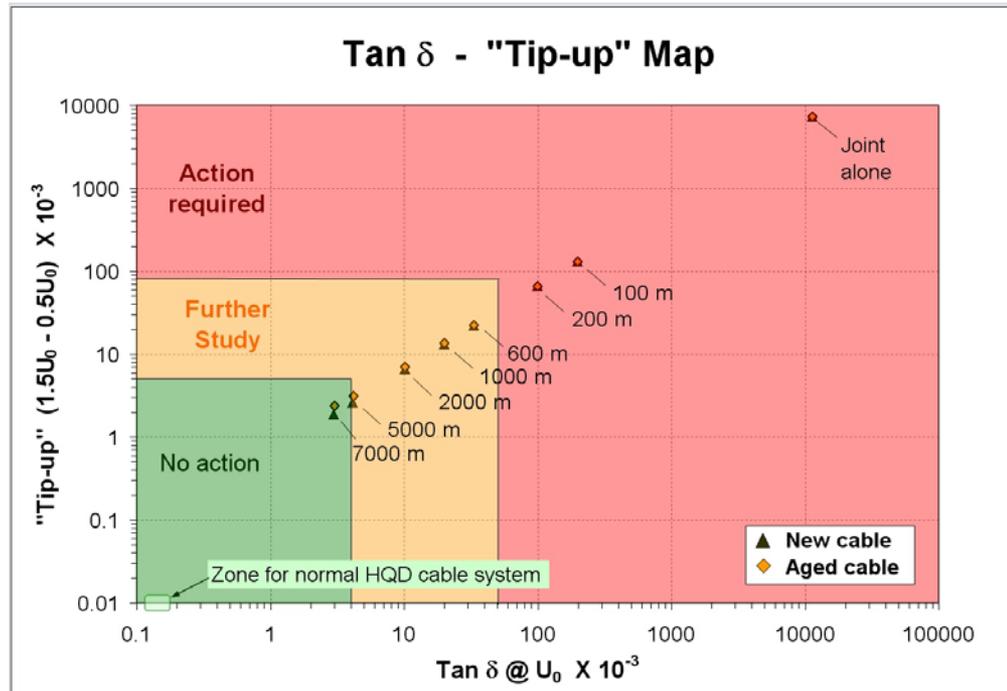
## Simulation results for joint type A:

**--> Cable length has a significant impact on VLF diagnostic outcome**
