## NEW REPAIR METHOD FOR A 380KV-FLUIDFILLED CABLE, DAMAGED BY IMPACT

Georg **SVEJDA**, Wien Energie Stromnetz, (Austria), [georg.svejda@wienenergie-stromnetz.at](mailto:georg.svejda@wienenergie-stromnetz.at),  
 Johannes **VAVRA**, Wien Energie Stromnetz, (Austria), [johannes.vavra@wienenergie-stromnetz.at](mailto:johannes.vavra@wienenergie-stromnetz.at)  
 Manfred **WANDA**, PRYSMIAN, (Austria), [manfred.wanda@prysmian.com](mailto:manfred.wanda@prysmian.com)  
 Nick **CRANE**, PRYSMIAN, (England), [nick.crane@prysmian.com](mailto:nick.crane@prysmian.com)

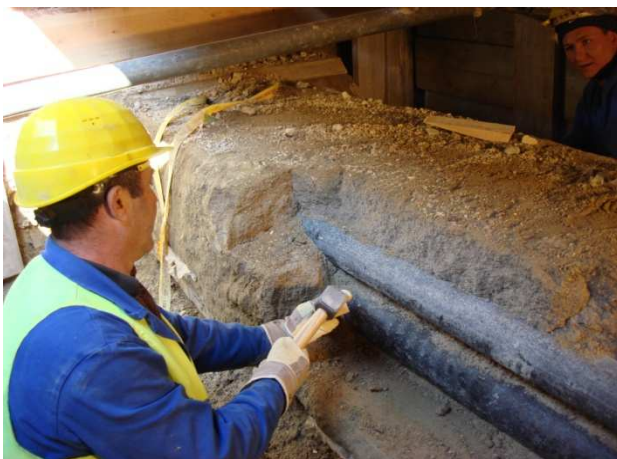
Fig.1 Removing backfill material with wooden wedges

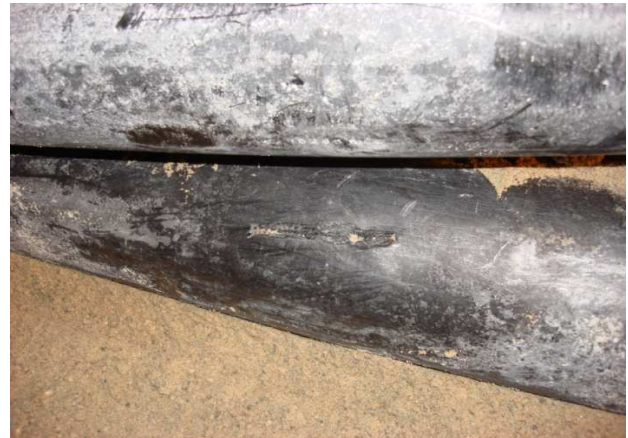
Fig. 2 Damage on a 380kV-Fluidfill cable

During work to connect the originally installed water cooling pipes (these were originally only nitrogen filled to allow leak detection if damaged by 3<sup>rd</sup> parties) to a new cooling station to allow the cable circuit to be water cooled and updated. It was necessary to expose the cooling pipes by carefully removing the backfill material by using wooden wedges (1). The situation near the old reversal point of the cooling pipes was different to the as built drawing. The backfill material was different in hardness to that which would normally have been installed thirty years ago. It was therefore difficult to distinguish the contact between the wooden wedge backfill or cable.

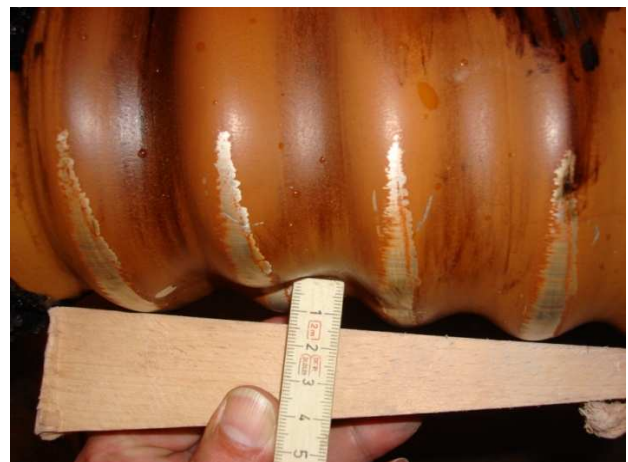
Fig. 3 Corrugated Aluminium Sheath damage after removal of outer polythene sheath
