## End of life of underground medium voltage cables on Pacific Islands

Blandine HENNUY, Sam PIOT; Laborelec, Belgium, [blandise.hennuy@laborelec.com](mailto:blandise.hennuy@laborelec.com), [sam.piot@laborelec.com](mailto:sam.piot@laborelec.com)  
Sébastien COULON; Electricité de Tahiti, French Polynesia, [sebastien.coulon@edt.pf](mailto:sebastien.coulon@edt.pf)

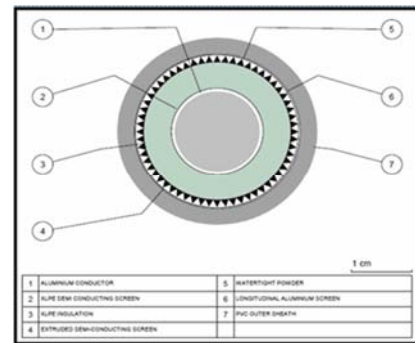
Fig. 2: Cable design

The cables are manufactured according to the French Standard NF C 33-223 [1]. The conductor is in aluminium with a cross-section of 150 mm<sup>2</sup>, the main insulation is cross-linked polyethylene, a powder for longitudinal water tightness is used, the screen is an aluminium longitudinally applied metal foil and the outer sheath is in PVC (figure 2).

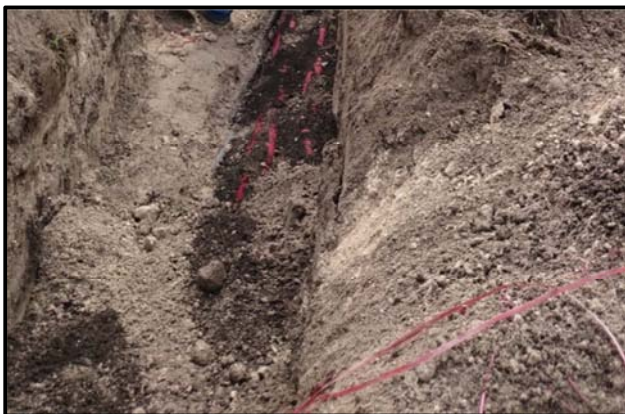
Fig. 1: Direct buried cables

About 60 km of cables are installed along the coast. They are laid directly in the ground (figure 1).
