Improved design for anti-scattering in fault condition of outdoor termination

M.H. JUN, Y.B. KIM, S.G. CHOI; Iljin Electric, Republic of Korea,
myunghun.jun@iljin.co.kr, youngbum.kim@iljin.co.kr, soogeol.choi@iljin.co.kr

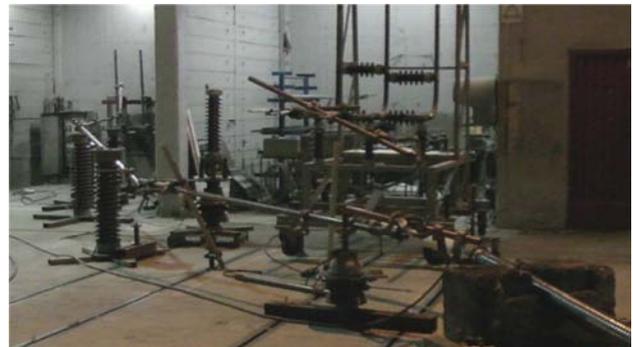
Fig. 1: Current supply

The apparatus under test consisted of a 150 kV composite oil cable termination and 20meters of cable sample. The cable termination was assembled on a frame representative of the actual installation in service.

The apparatus was supplied by cable core and the return circuit by the screen.

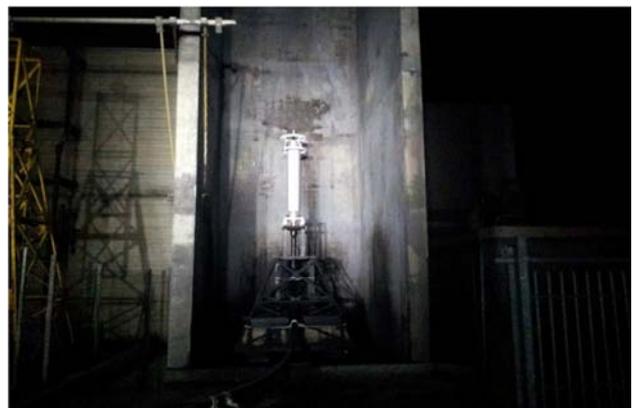
Fig. 2: Front view

The experiment was conducted in the following circumstances.
