## Characteristics of Electrical Treeing Initiation and Propagation in Silicone Rubber

Yun-xiao ZHANG, Yuan-xiang ZHOU (1), Xu ZHANG (2), Rui LIU (3)

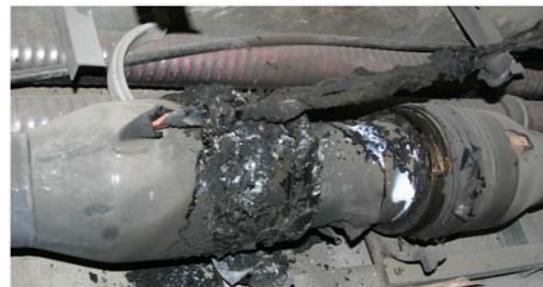
(a) Failure cable accessory

Silicone rubber (SIR) is widely used as main insulation material of prefabricated cable accessories due to its excellent electrical, thermal and mechanical performance. Electrical tree is an important reason of insulation failure in polymeric dielectrics. In fact, electrical tree is a kind of insulation defect which looks like tree. Occasional breakdown failures caused by electrical tree in SIR have threatened the reliability of extra-high-voltage XLPE (cross-linked polyethylene) power cable lines which have been strongly developed. Figure 1(a) shows the failure cable accessory used in the power cable line where the breakdown phenomenon caused by electrical tree was found (as shown in Figure 1(b)).

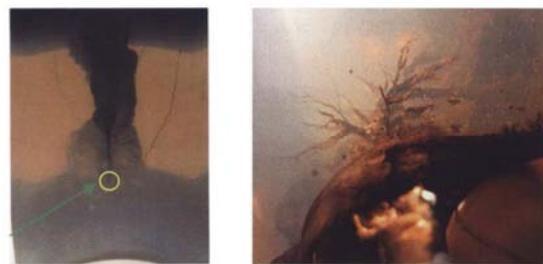
(b) Electrical treeing channels found in Fig. 1(a)

**Fig. 1: Failure cable accessories and its electrical treeing channels**
