Belgian experience with a sheath current monitoring system installed on a critical 150 kV cable

Pieter **LEEMANS**, Laurence **De MUYTER**, Peter **De RIDDER**, Elia (Belgium), pieter.leemans@elia.be, laurence.demuyter@elia.be, peter.deridder@elia.be

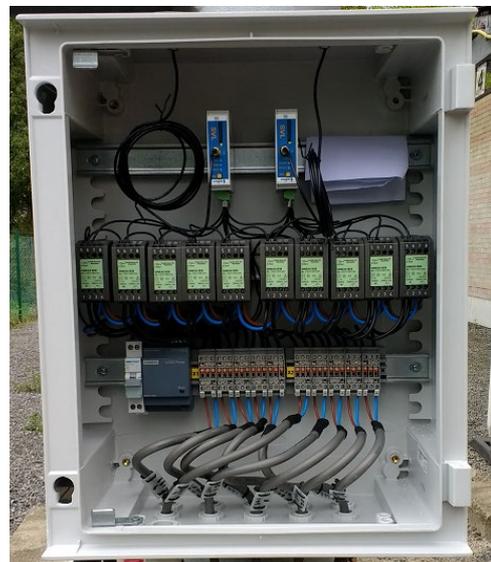
Every 150 kV cable connection consists three major sections. Each circuit has two ECC's. To monitor each major section, current transformers are installed at each section on all cable screens and ECC's. A data logger with 4G modem connects the current transformers to send the measurement data to a central server. In figure 1 an overview of the cabinet of the monitoring system is shown.

Fig. 1: Cabinet of monitoring system
