PARTIAL DISCHARGE DETECTION AND 3D-LOCALIZATION AT 110-KV-CABLE TERMINATIONS USING UHF-SENSORS

Rouven **Berkemeier**, Robert **Bach**; South Westphalia University of Applied Sciences, Germany, berkemeier.rouven@fh-swf.de, bach.robert@fh-swf.de

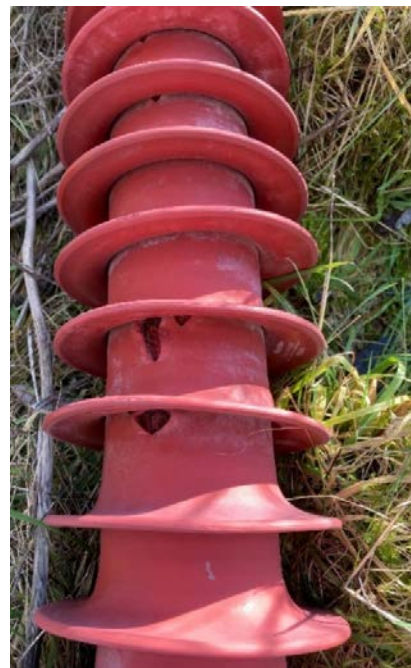
The six cable terminations of the XLPE-cables (S2XS2YFuG 1x120 RM/25 64/110 kV) were replaced due to visual defects. Figure 1 shows an example of one of these defects:

Figure 1: Example of visual defect at the cable terminations
