## EVALUATION OF FIELD AGED PILC CABLES 66 AND 68 YEARS

The Electric Power Research Institute worked with Cable Technology Laboratories to evaluate the health and performance of samples of PILC cables removed from service. The cables were operated in  $U_0 = 4$  kV network systems. This report describes the physical and electrical tests and findings of the evaluation of two field aged PILC cables of 66 and 68 years. One cable contained a field failure attributed to moisture ingress due to localized lead sheath corrosion. The remainder of the two cables were in very good condition for their age and could have provided further reliable service.

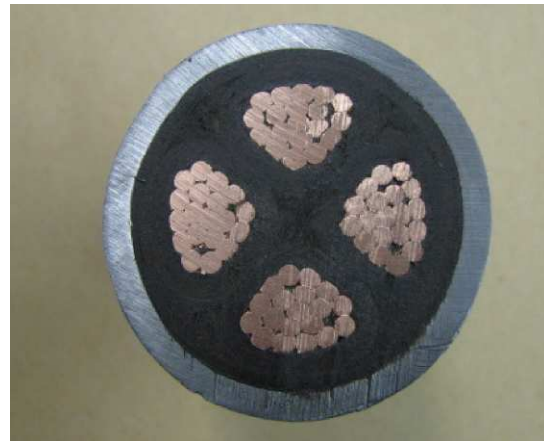
Figure 1 – Cable A: 1937 PILC cable, 68 years service

The 1937 cable was a 4 conductor, 7 kV belted design operating in a 4 kV phase-to-phase system. Copper conductors were 33.6 mm<sup>2</sup>. Phases had 2.41 mm oil impregnated paper tapes (19 x 0.13 mm thick tapes) with a 1.65 mm thick overall belt (13 x 0.13 mm thick tapes). The lead sheath was 2.5 mm thick with no overall jacket. There were paper fillers in the center and outer interstices of the cable core to make the cable round. The cable cross section is shown in Figure 1. Seventy meters of cable was supplied for testing. This cable will be referred to as "Cable A".
