# A Study on the Effect of Performing VLF Withstand Tests on Field Aged Degraded Joints

Jean-François DRAPEAU

Jicable'11

21 June 2011

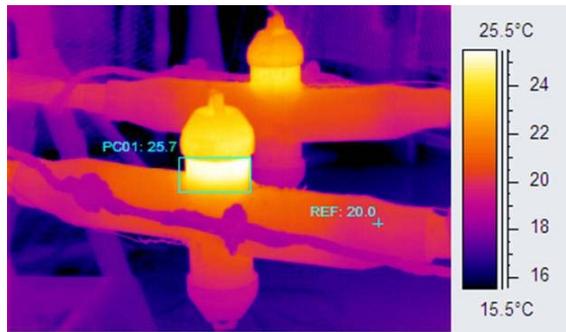
Type A

**Disconnectable straight joint with taps design**

- 3 samples showing "reduced signs of degradation"
- Anomaly = localized "spot" in the "tap"

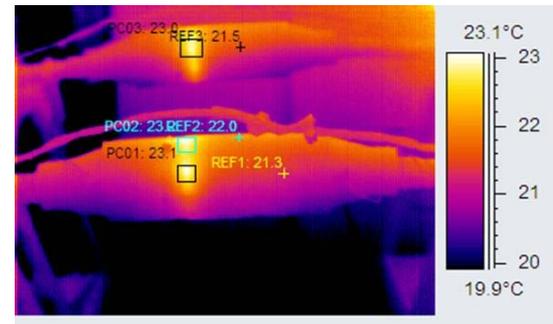
Type B

**Premolded straight joint design**

- Two distinct groups: "bad" (6) vs "good" (8)
- Among 6 "bad", there are 4 failures
- When initial condition of the joint is good ---> No measurable impact

- 1 sample showing "reduced signs of degradation"  
This sample had a particular "heat signature"  
--> localized hot spot in the "shoulder"
