A STUDY ON THE EFFECT OF PERFORMING VLF WITHSTAND TESTS ON FIELD AGED DEGRADED JOINTS

Jean-François **DRAPEAU** (1), Jacques **CÔTÉ** (2), Simon **BERNIER** (1)

1 - IREQ (Hydro-Québec), Varennes, Québec, Canada, drapeau.jean-francois@ireq.ca, bernier.simon@ireq.ca

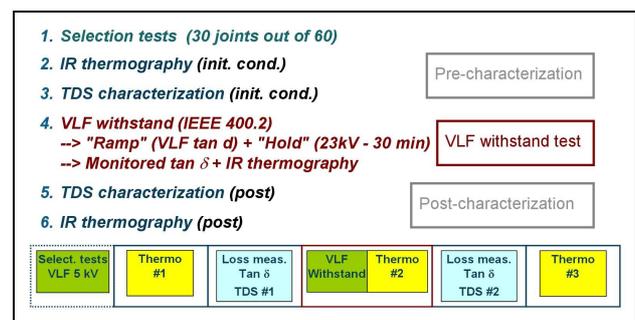
The test protocol used for this investigation is shown in Figure 1. It is based on the principle of performing a "pre-characterization" prior to the VLF withstand, followed by a "post-characterization, aiming to evaluate the differences of monitored features "after" vs. "before" the execution of the VLF withstand test. The monitored features are the surface temperature characteristics, measured through an infrared (IR) thermography examination protocol, and the dielectric loss measured with Time Domain Spectroscopy (TDS) [4].

Figure 1: Test protocol for joint condition evaluation
