## A STUDY ON THE EFFECT OF PERFORMING VLF WITHSTAND TESTS ON FIELD AGED DEGRADED JOINTS

### ABSTRACT

In this study, VLF withstand tests were performed on MV joints with various levels of degradation. Joint samples were identified in the field as those showing abnormal heat patterns during infrared imaging examination. A total of 30 aged joints were removed from service and tested in laboratory. The resulting effect of VLF withstand on their condition was evaluated by comparing the surface temperature rise and dielectric loss after vs. before performing the VLF withstand test. In addition, VLF diagnostic features relating to the condition of the joint were investigated and are discussed in terms of their applicability to cable systems according to the length.

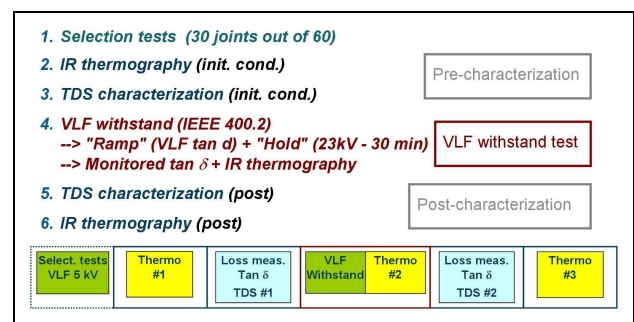
The test protocol used for this investigation is shown in Figure 1. It is based on the principle of performing a "pre-characterization" prior to the VLF withstand, followed by a "post-characterization, aiming to evaluate the differences of monitored features "after" vs. "before" the execution of the VLF withstand test. The monitored features are the surface temperature characteristics, measured through an infrared (IR) thermography examination protocol, and the dielectric loss measured with Time Domain Spectroscopy (TDS) [4].

Figure 1: Test protocol for joint condition evaluation
