## THE NECESSITY ANALYSIS OF DISTRIBUTED FIBER-OPTIC TEMPERATURE MONITORING BY XIAMEN POWER CABLE ALARM CASE STUDY

YAN Youxiang, SU Xueyuan, (China), Xiamen Electric

XIAO Chuanqiang, (China), SINDIA Instruments Co., Ltd, xiao@sindia.cn

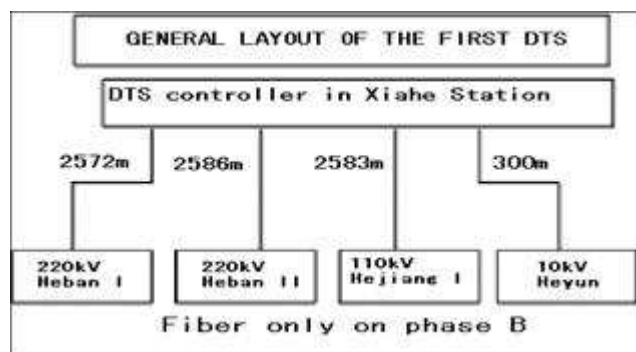
The first DTS system was put into operation in 2005, with 4 channels monitoring two 220 kV lines, one 110 kV line, and one 10 kV line respectively (as shown in Figure 1). The monitoring results, as well as the corresponding temperature curve plotted in real-time, were accessible via the internal networks for the authorized personnel. In addition, the DTS system includes the capability to automatically update the maximum temperatures and locations in each channel via SMS to any designated mobile addresses. Valuation and testing results indicate that these features of DTS have improved the efficiency of power cable maintenance to considerable extents.

Fig. 1 Power cable temperature monitoring system
