HYDRO-QUÉBEC EXPERIENCE WITH INFRARED IMAGING FOR THE MAINTENANCE OF THE UNDERGROUNDS MEDIUM-VOLTAGE CABLE SYSTEM

Jacques CÔTÉ, André BELLEMARE, Hydro-Québec Distribution, Canada,
cote.jacques.3@hydro.qc.ca, bellemare.andre@hydro.qc.ca

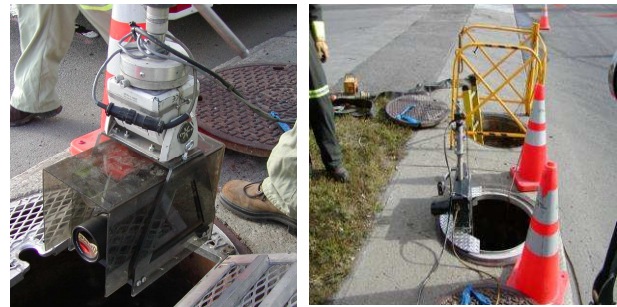
To perform the first step from outside the manhole, the infrared camera is placed in a protective housing with a remote-controlled pan and tilt, all mounted on a pole. Figure 1 shows the arrangement. Images are sent to the worker sitting in the vehicle.

Figure 1. Left: housing with pan and tilt; right: pole placed into manhole

In this first step, the operator looks at the infrared spectrum and the visible spectrum for anomalies. If there is any object with a temperature exceeding 130 degrees Celsius or an abnormal heat pattern (see Method section), the inspection is halted and manhole entry is prohibited until the abnormal accessory has been de-energized and replaced. Otherwise, the worker is allowed to enter the manhole to measure the current load. The load is measured with a clip-on ammeter, and the values are used in the diagnostic.
