## HYDRO-QUÉBEC EXPERIENCE WITH INFRARED IMAGING FOR THE MAINTENANCE OF THE UNDERGROUNDS MEDIUM-VOLTAGE CABLE SYSTEM

Jacques CÔTÉ, André BELLEMARE, Hydro-Québec Distribution, Canada,  
[cote.jacques.3@hydro.qc.ca](mailto:cote.jacques.3@hydro.qc.ca), [bellemare.andre@hydro.qc.ca](mailto:bellemare.andre@hydro.qc.ca)

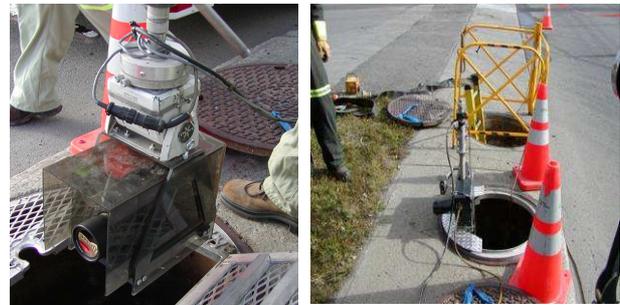
To perform the first step from outside the manhole, the infrared camera is placed in a protective housing with a remote-controlled pan and tilt, all mounted on a pole. Figure 1 shows the arrangement. Images are sent to the worker sitting in the vehicle.

Figure 1. Left: housing with pan and tilt; right: pole placed into manhole

In this first step, the operator looks at the infrared spectrum and the visible spectrum for anomalies. If there is any object with a temperature exceeding 130 degrees Celsius or an abnormal heat pattern (see Method section), the inspection is halted and manhole entry is prohibited until the abnormal accessory has been de-energized and replaced. Otherwise, the worker is allowed to enter the manhole to measure the current load. The load is measured with a clip-on ammeter, and the values are used in the diagnostic.
