## Condition assessment of high voltage (22 kV) Aerial Bundled Cable (ABC)

Martin **MUXWORTHY**, Mark **MAFFEI**, Graeme **ALEXANDER**; Nexans-Olex, (Australia),  
[martin.muxworthy@nexans.com](mailto:martin.muxworthy@nexans.com), [mark.maffei@nexans.com](mailto:mark.maffei@nexans.com), [graeme.alexander@nexans.com](mailto:graeme.alexander@nexans.com)

Nexans-Olex Engineering Support Services were engaged in 2014 to conduct a condition assessment of existing 22 kV rated High Voltage Aerial Bundled Cables (HV ABC).

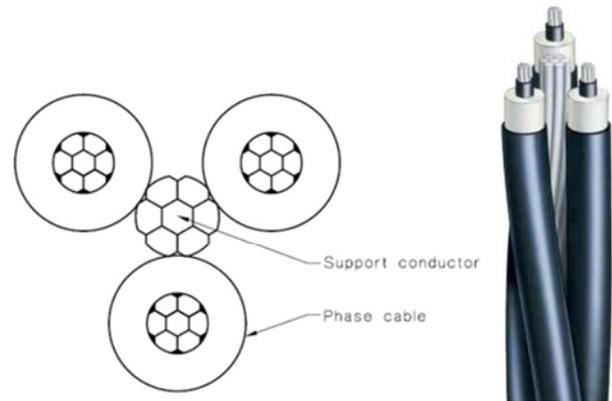
In the case of this particular site the NMS HV ABC was adopted and progressively installed from 2010 until 2012. The images below detail the construction of this product.

**Fig. 1: High Voltage Non-Metallic Screened Aerial Bundled Cable (HV NMS ABC)**

Since the NMS type of HV ABC does not have an earthed screen around each core, the support conductor plays a vital role in ensuring capacitive charging currents, and in the unlikely event of cable failure, earth fault currents are carried back to the supply voltage source. The means to conduct these currents are via the contact surface between the support conductor and the semiconductive insulation screen material.
