## RED ELECTRICA'S OPERATING EXPERIENCE ON 400KV INTERCONNECTION SPAIN-MOROCCO.

Maria Dolores LÓPEZ-MENCHERO CÓRDOBA, Rafael GARCÍA FERNÁNDEZ, Miguel Ángel PÉREZ LOUZA, Red Eléctrica de España, (Spain), [malopez@ree.es](mailto:malopez@ree.es), [rafgarcia@ree.es](mailto:rafgarcia@ree.es), [maperez@ree.es](mailto:maperez@ree.es),

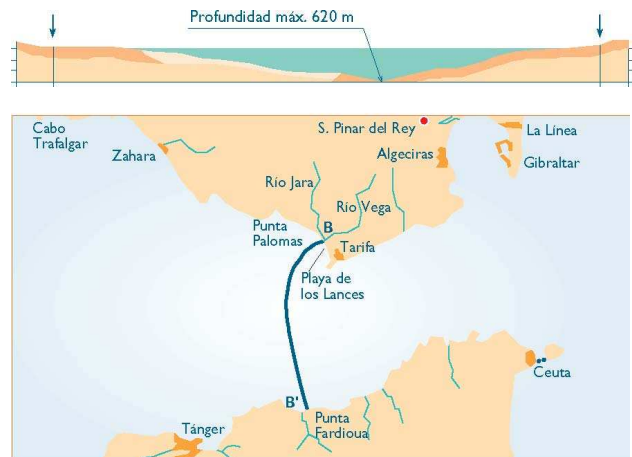
Fig.1: route of the 400 kV Spain-Morocco Interconnection.

On the Spanish coast, there is an underground part of about 2, 5 km between Tarifa and the sea-land joints. This underground part is owned by REE.
