### B.4.1.

Effects of sea salt sediment on 110 kV cable stations on the Croatian Adriatic coast  
ALIJINOVIC S., HEP Transmission., Croatia

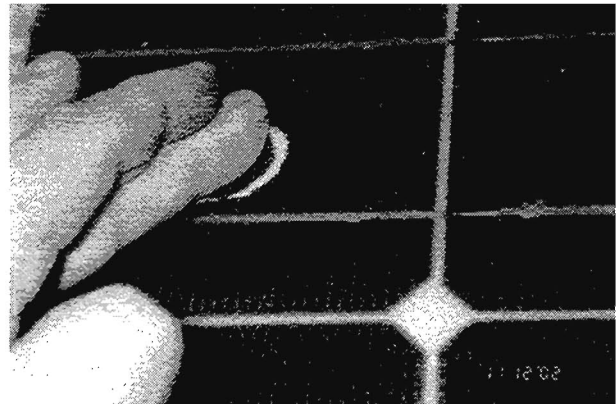
When the water has evaporated, the tiny crystals of salt float in the air carried by the wind. Those crystals, together with concentrated salt solution, fall onto the ground, trees, other objects and people.

Figure 2: Crystals of salt on a solar cell 10 min. after cleaning
