#### Diagnostic method for water tree aging XLPE cable with residual charge measurement

TOYA A., TANAKA A., Tokyo Electric Power Company, Japan  
OOTAKA I., EXSYM Corporation, Japan  
SAKAMOTO T., Mitsubishi Cable Industries Ltd., Japan

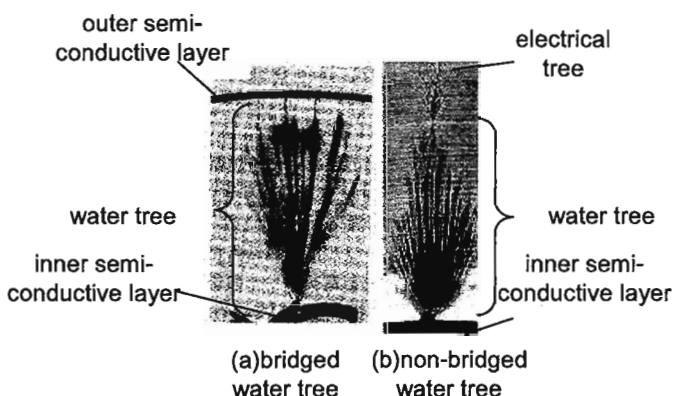
Fig.1 Shapes of water tree

In case of under 6.6kV class XLPE cable, it is known that the origin of insulation breakdown is water tree bridged between conductor and shield as shown in fig.1(a)(bridged water tree). It is easy to detect this
