# ADVANCED SOLUTION FOR ON-SITE DIAGNOSIS OF DISTRIBUTION POWER CABELS

Edward GULSKI, Delft University of Technology, (The Netherlands), [e.gulski@tudelft.nl](mailto:e.gulski@tudelft.nl)  
Johan J SMIT, Delft University of Technology, (The Netherlands), [j.j.smit@tudelft.nl](mailto:j.j.smit@tudelft.nl)  
Frank PETZOLD, SebaKMT, (Germany), [petzold.f@sebadyn.de](mailto:petzold.f@sebadyn.de)  
Paul P. SEITZ, Seitz Instruments AG, (Switzerland), [pps@seitz-instruments.ch](mailto:pps@seitz-instruments.ch)  
Ben QUAK, Seitz Instruments AG, (Switzerland), [bq@seitz-instruments.ch](mailto:bq@seitz-instruments.ch)  
Frank de VRIES, NUON Tecno, (The Netherlands), [frank.de.vries@nuon.com](mailto:frank.de.vries@nuon.com)

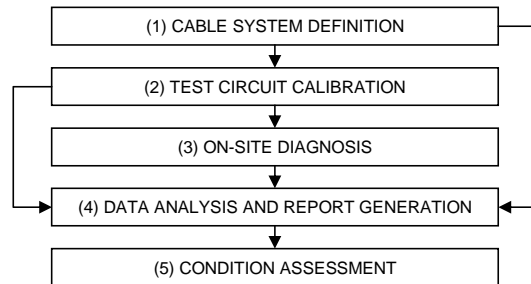
Figure 2: Integral approach for condition assessment of medium voltage power cables by means of on-site diagnosis.

particular, using non-destructive e.g. off-line diagnostics realistic data and reproducible patterns of discharges in a power cable can be obtained. Moreover with regard to implementation of to support utility asset management (AM) in decision processes about maintenance and replacement policy integral approach is necessary, where the following steps have to be considered (see figure 2).

The above mentioned procedure is based on 7 years field experiences as obtained in world-wide implementation of PD diagnosis for condition assessment of MV power cables. In figure 2 the philosophy behind the above mentioned process is shown. It follows from this flowchart that the major carrier in the execution of condition assessment is the information about the cable system parameters, the diagnostics data and advanced analysis. In this paper based on these steps integral approach will be discussed more in details.
