3 kHz ACCELERATED GROWTH OF WATER TREES IN MEDIUM VOLTAGE EXTRUDED CABLES

Blandine HENNUY, Quentin DE CLERCK, Laborelec, (Belgium),
blandise.hennuy@laborelec.com, quentin.declerck@laborelec.com

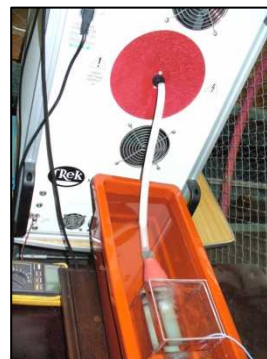
Figure 3: power amplifier

The experimental set-up consists in a 30 kV, 5 kHz, 40 mA power amplifier (Figure 3) and a cell containing salt solution immersed in a thermo-regulated oil bath (Figure 4) to avoid any electrical discharge at the connection of the high voltage lead.
