Resilient 12 to 36 kV touch-safe aerial network solution with a competitive Total Cost of Ownership

Lars Efraimsson, Ingvar Hagman, Johan Åhman ; nkt cables AB, Falun; Sweden,
email: lars.efraimsson@nktcables.com, ingvar.hagman@nktcables.com, johan.ahman@nktcables.com

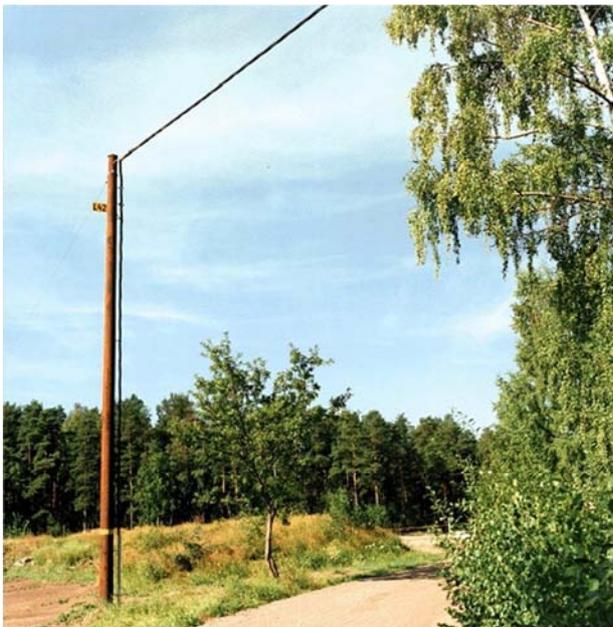
Fig.1. Cable from coming up from ground and going further as aerial cable

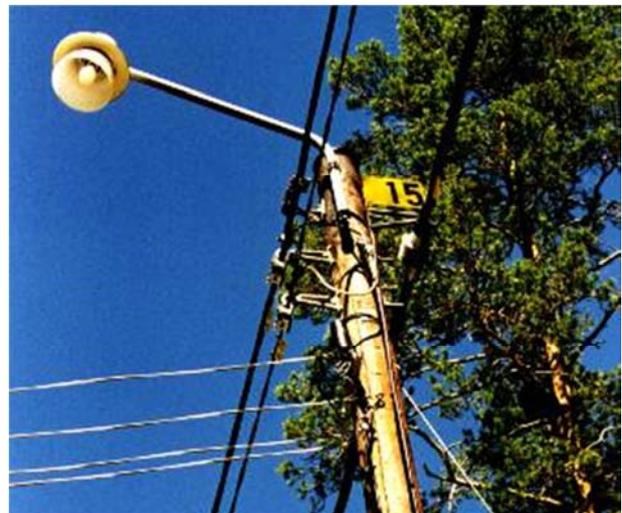
Fig.2. Joint installation between 24 kV, 1 kV, electric light and telecom cables
