EVALUATION OF THE CONDITION AND THE PERFORMANCE OF UNDERGROUND FLUID FILLED HV LINKS AT HYDRO-QUÉBEC

Christian ROYER, Hydro-Québec, (CANADA), royer.christian@hydro.qc.ca
Ray AWAD, Hydro-Québec, (CANADA), awad.ray@hydro.qc.ca

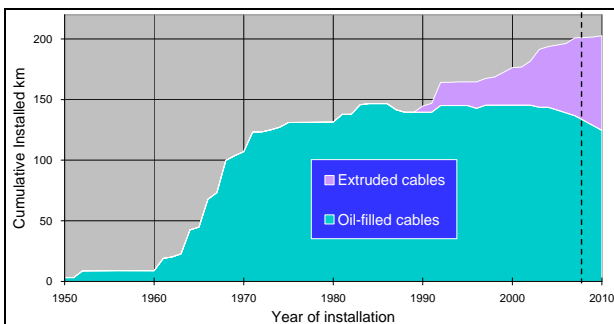
Figure1. Cumulative installed HV underground links at Hydro-Québec (km)

More than seventy (70) of these links, representing 60% of the network in length, were installed in the sixties and the seventies, using Fluid Filled Cables installed in duct banks and manholes. Since 1989, all new links are built using XLPE insulated cables and pre moulded accessories.

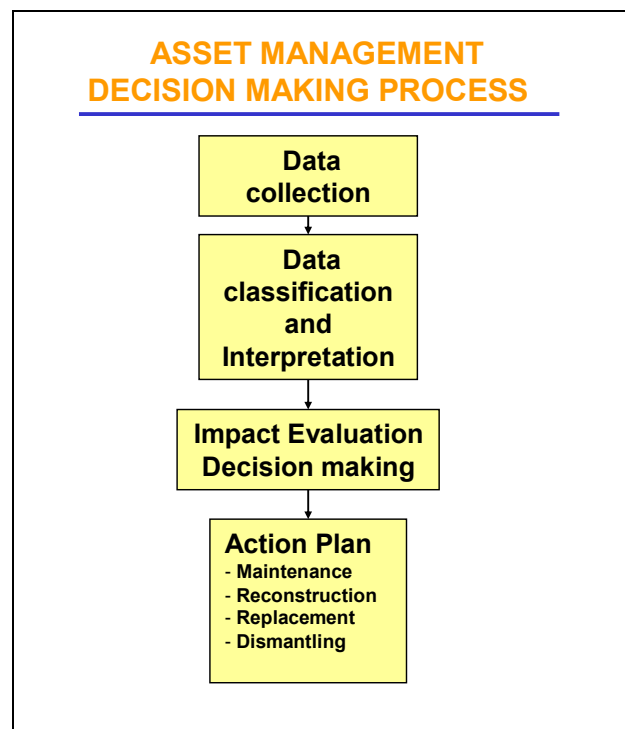
Figure 2. Asset management simplified process

The asset management process can be described by the following four steps, as illustrated in figure 2.

- Step 1. Data collection. This includes all existing data, available from records, and operational data that are collected mainly by maintenance crews. In order to collect useful data, one must have a very good knowledge of the links to be evaluated.
- Step 2. Data classification and interpretation. This step consists of the organisation of data to filter out the most useful information from all the available data.
- Step 3. Impact evaluation and decision making. The evaluation of a link should take into account not only the available data, but also other factors like the strategic importance of a link. Each decision should be made taking into account its global impact on the system.
- Step 4. Action plan. All the decisions taken in step 3 will result in a global action plan; that will help achieve the expected goals of reliability of the network.

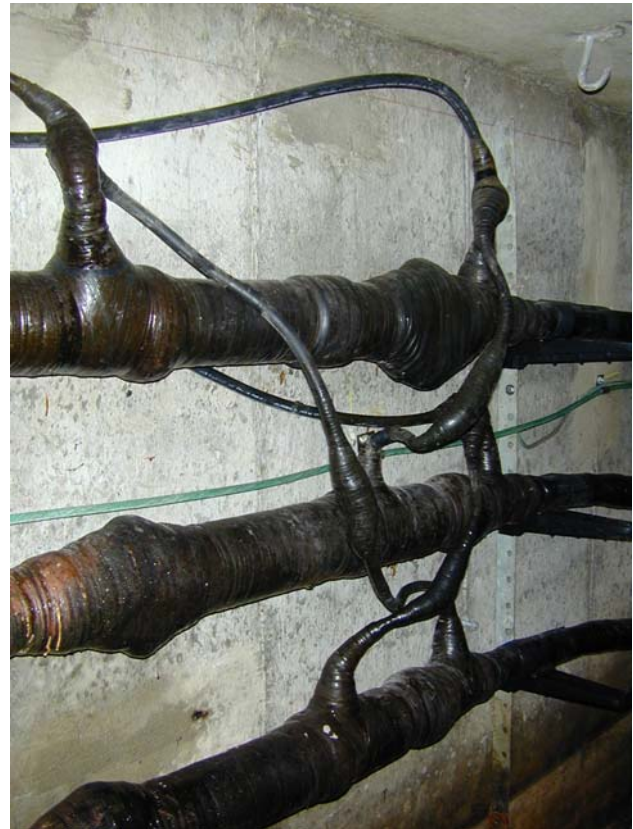
Figure 3. 120kV sectionalized joints in a manhole

In case of sectionalized joints, a fault may be caused by a flashover across the casing insulator, due to excessive transient voltages.

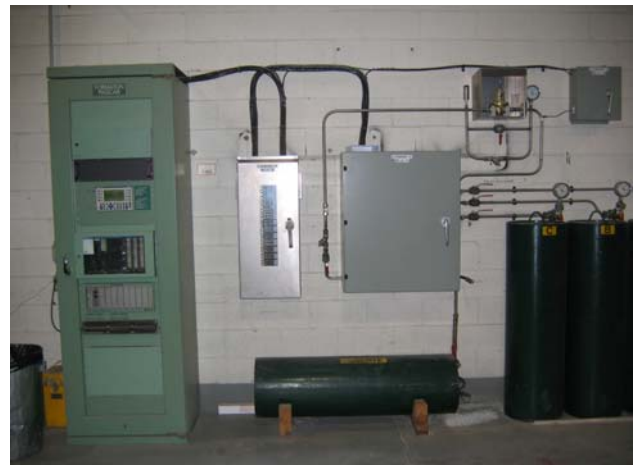
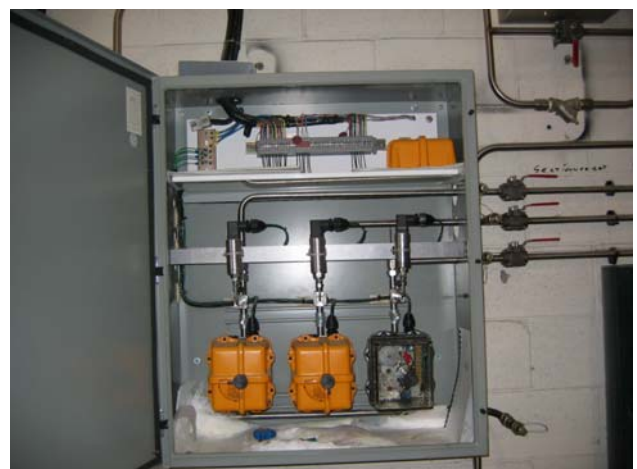
Figure 4. Automated oil pressure monitoring system.

Older systems are fitted with pressure gauges with contacts for alarm relaying. In some cases, the pressures gauges have been replaced by pressures switches and transducers, connected to an electronic monitoring system called **PASCAB**. The new monitoring system greatly increased the reliability and performance of many links by permitting earlier detection of abnormal conditions.

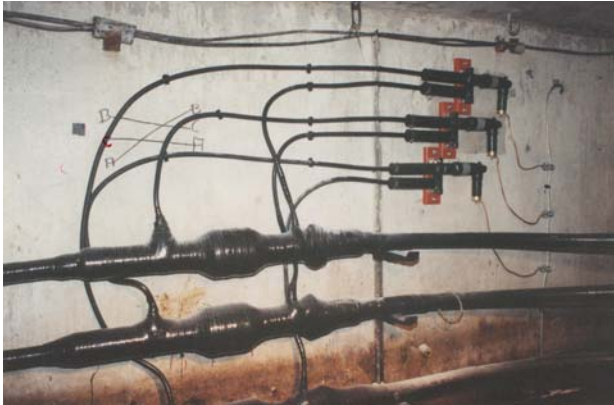
Figure 5 shows an example of cross-bonding in a manhole, using submersible SVL's at the cross-bonding point for sheath protection.

Figure 5. Cross bonding system in a manhole.

Damage can occur on some SVL's due to water ingress or high voltage transients. Water ingress in joint coverings is sometimes observed, usually combined with oil leakage at the joint.

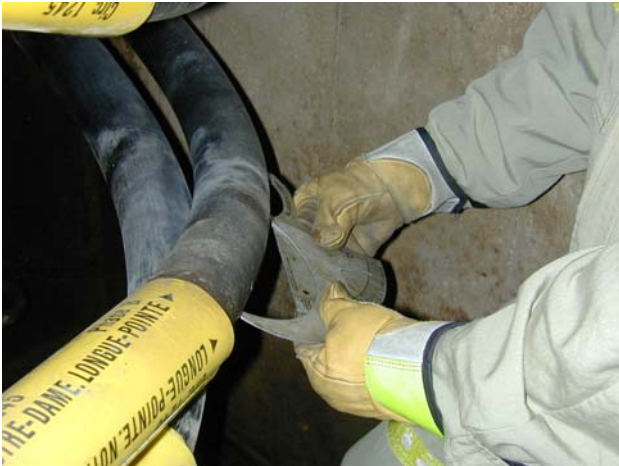
Figure 6: Measuring bending radius during inspection

This indicator is based on the observation of thermo-mechanical movement of cables in manholes. Excessive bending of cables in manhole can lead to oil leaks and eventually insulation failure. In some cases, excessive bending is observed, but the situation has stabilised. Those cases are considered less severe than those where the cable bending radius continues to deteriorate .

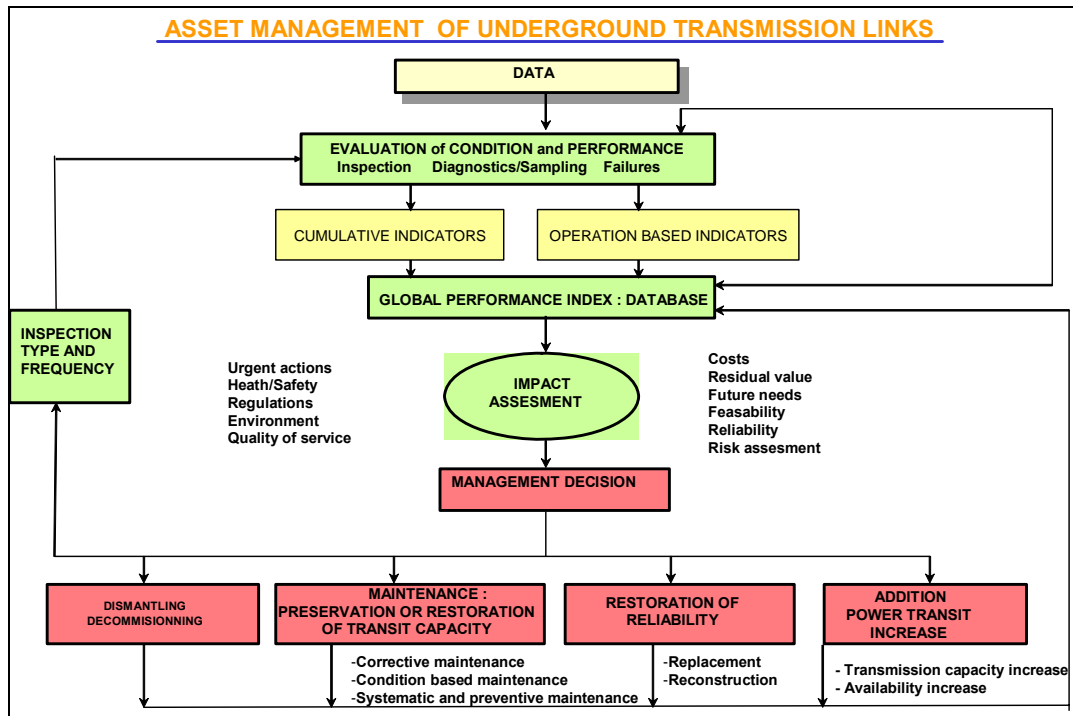
Figure 8: Asset management decision process for HV underground links
